SUBJ: RCRA Compliance Evaluation Inspection
Mesker Door, Inc.
EPA ID # ALR000003236

RCRA Inspection Report

MESKER DOOR, INC.

COMPLIANCE EVALUATION INSPECTION PHOTOGRAPHS

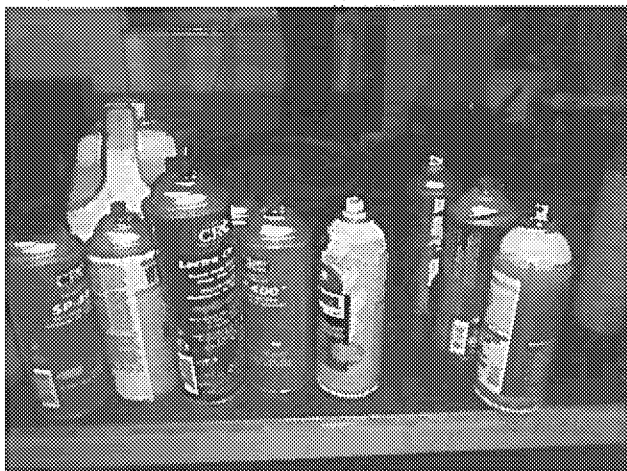
At the time of the inspection, the inspectors observed discarded aerosol cans in the trash (Picture 1). The inspectors explained that unless the discarded cans are RCRA empty, no propellant is released when the nozzle is pressed, then the cans must be collected and stored until a waste determination can be conducted.

Picture 1 – Maintenance Shop aerosol cans discarded in the garbage

Pursuant to ADEM Admin. Code r. 335-14-3-.01(2) [40 C.F.R. § 262.11], a person who generates a solid waste, as defined in ADEM Admin. Code r. 335-14-2-.01(2) [40 C.F.R. § 261.2], must determine if that waste is a hazardous waste following the methods articulated in ADEM Admin. Code r. 335-14-3-.01(2) [40 C.F.R. § 262.11].

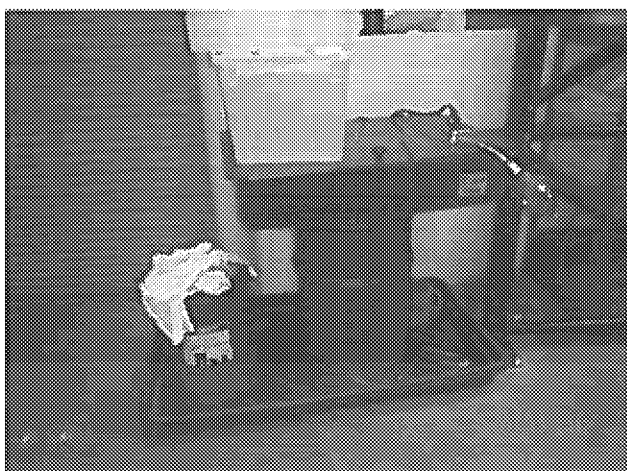
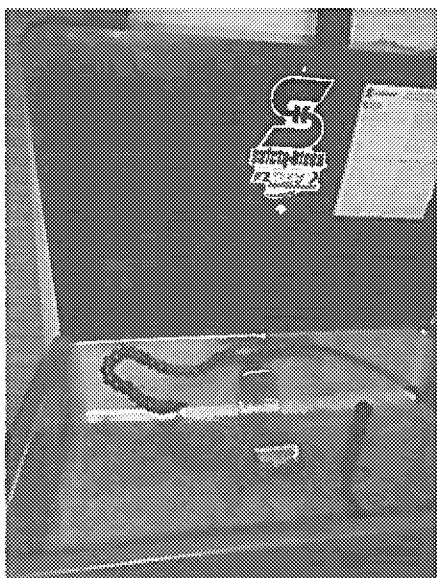
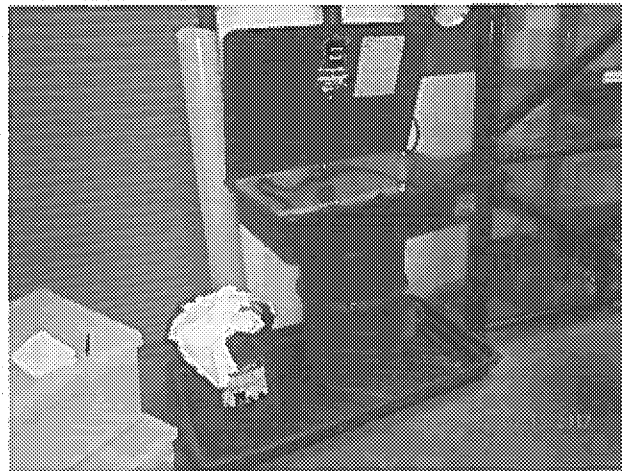
Next to the Maintenance area was the Compressor Room, where supplies were being stored. The inspectors observed a Safety Kleen Systems parts washer, unplugged and sitting in a secondary containment tray, and an oily waste can, that was closed and labeled (Pictures 2-4). No issues were noted in this area.

Picture 4 – Compressor Room SKS parts washer

Picture 2 – Compressor Room SKS parts washer

Picture 3 – Compressor Room SKS parts washer

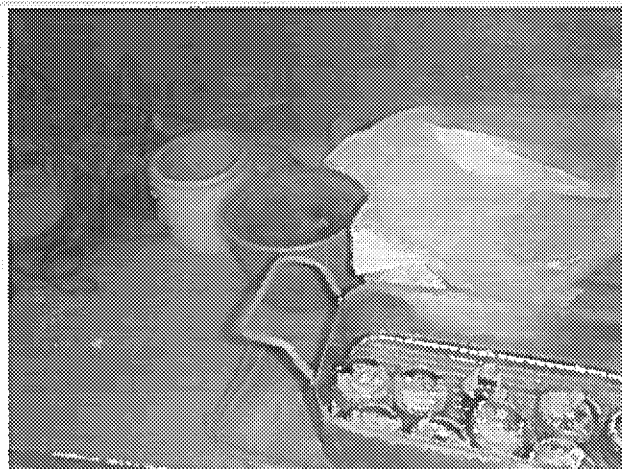
The Paint Booth was in use at the time of the inspection. The inspectors observed on the top of the Paint Booth a work bench that contained a small container of solvent with nozzles for the automatic spray booth soaking inside (Picture 5).

Picture 5 – Paint Booth cup of solvent soaking nozzles

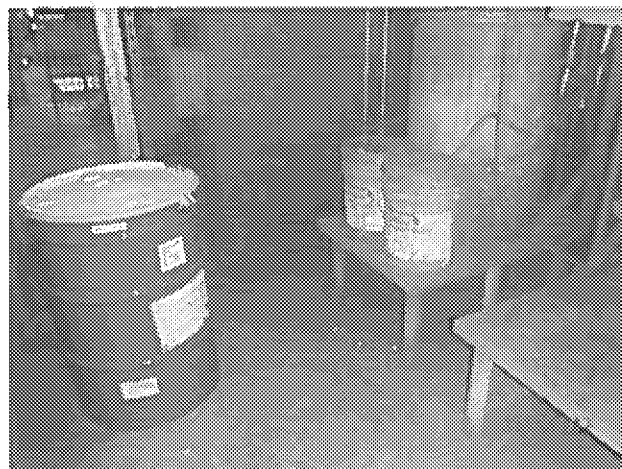
The Paint Kitchen is located below the Paint Booth. The inspectors observed a gray 55-gallon of clean water used for flushing and two 5-gallon containers of liquid waste flushed from the paint booth (Pictures 6, 8). Next to these containers was a blue 55-gallon drum of liquid waste that was one-third full (Pictures 6-7). These containers were not marked or labeled with their contents. Beside the flushing station, was a work table, a drying paint drum that was RCRA empty and a black 55-gallon drum used as a trash can. The inspectors observed a discarded Zinc-It aerosol can inside (Pictures 9-10). The can was not RCRA empty, the label was marked extremely flammable and the safety data sheet stated "If discarded, this product is considered a RCRA ignitable waste, D001."

Picture 6 – Paint Kitchen liquid waste containers and drum

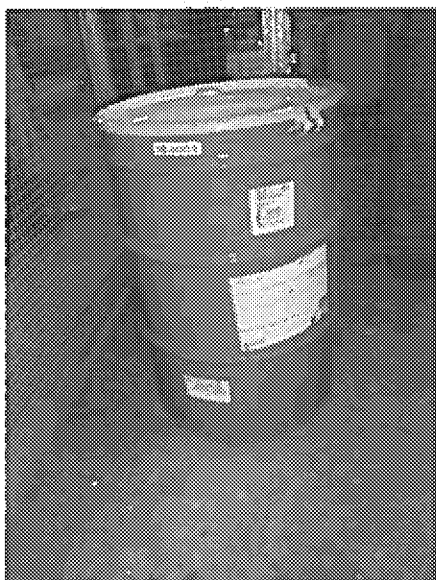
Picture 7 -- Paint Kitchen liquid waste drum

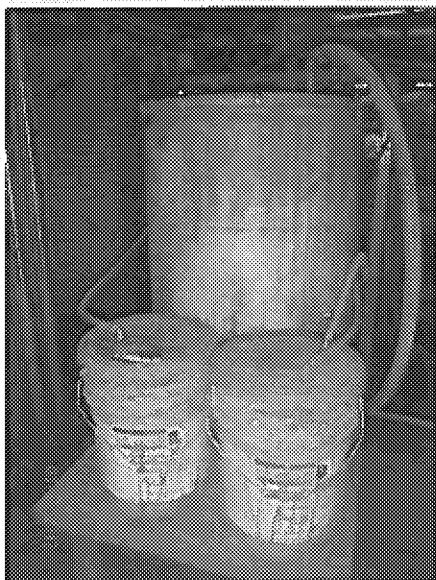
Picture 8 -- Paint Kitchen liquid waste collection containers and clean water drum

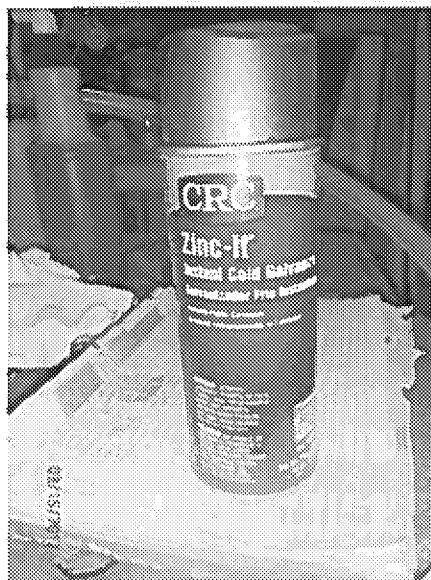
Picture 9 -- Paint Kitchen garbage can with a discarded aerosol can

Picture 10 -- Paint Kitchen a discarded aerosol can from the garbage can

Again the inspectors stated that discarded aerosol cans that are not RCRA empty should be collected and stored until a waste determination can be conducted.

Pursuant to ADEM Admin. Code r. 335-14-3-.01(2) [40 C.F.R. § 262.11], a person who generates a solid waste, as defined in ADEM Admin. Code r. 335-14-2-.01(2) [40 C.F.R. § 261.2], must determine if that waste is a hazardous waste following the methods articulated in ADEM Admin. Code r. 335-14-3-.01(2) [40 C.F.R. § 262.11].

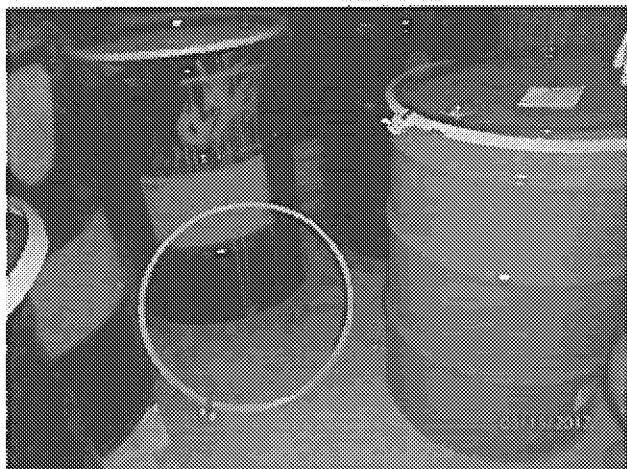
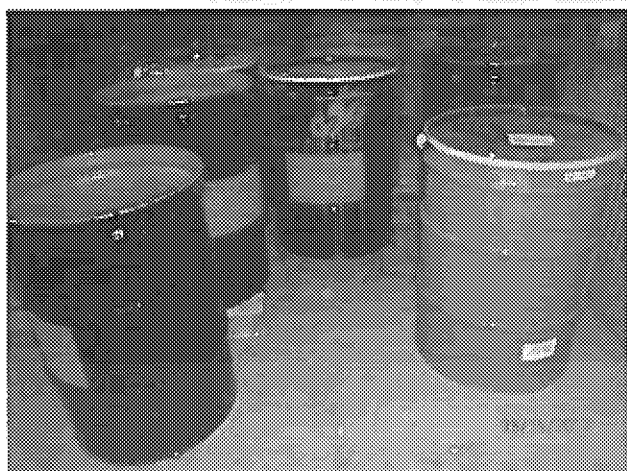
The inspectors observed two black 55-gallon drums of liquid waste stored near the process (Pictures 11-12). The drums were generated from the Paint Kitchen, and were full, closed but not labeled or dated. Mr. Jeglum said the drums were to be moved to Chemical Storage. The inspectors explained that to ensure that liquid waste was being properly disposed of, a waste determination was required because of the use of solvent in the flushed water and in the paint.

Picture 11 – Flow Coat Process two not labeled and not dated waste liquid drums

Picture 12 – Flow Coat Process two not labeled and not dated waste liquid drums

Pursuant to ADEM Admin. Code r. 335-14-3-.01(2) [40 C.F.R. § 262.11], a person who generates a solid waste, as defined in ADEM Admin. Code r. 335-14-2-.01(2) [40 C.F.R. § 261.2], must determine if that waste is a hazardous waste following the methods articulated in ADEM Admin. Code r. 335-14-3-.01(2) [40 C.F.R. § 262.11].

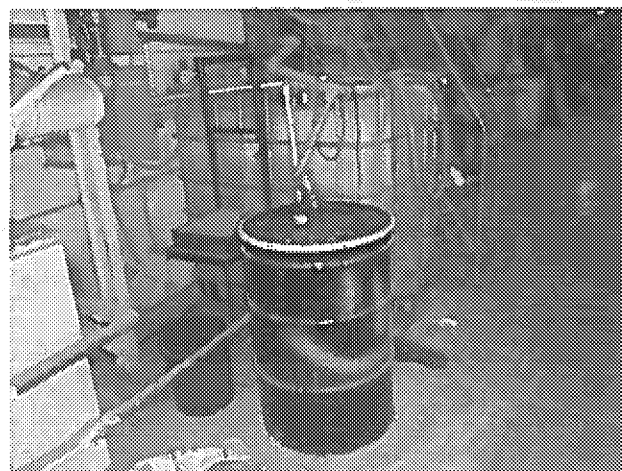
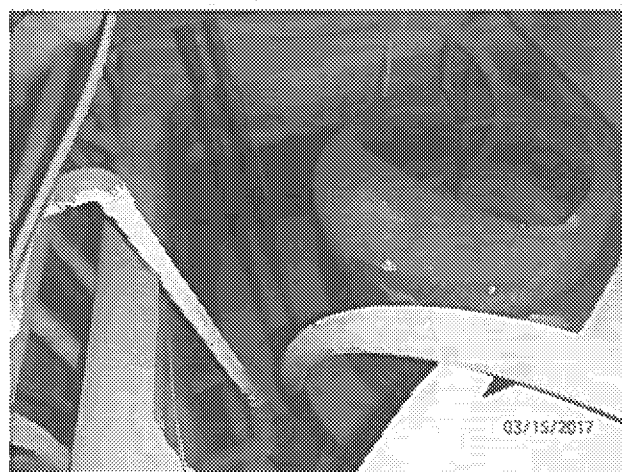
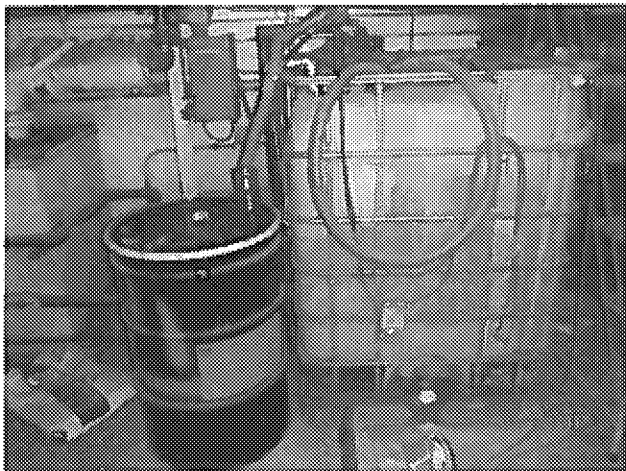
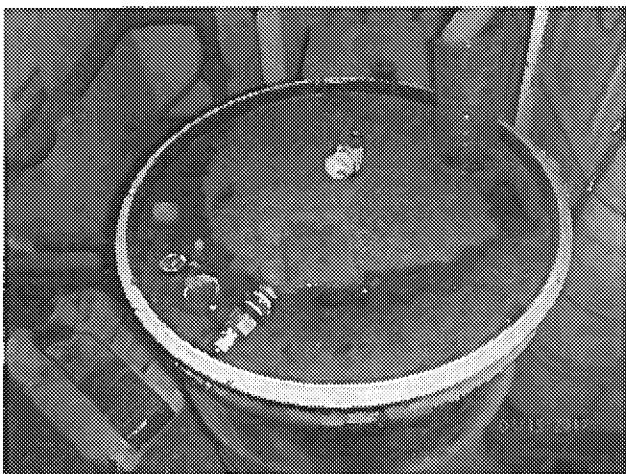
The Tunnel Wash System (Line) cleans the doors and frames. The line is a three-stage wash system consisting of: Stage 1 –Houghto-Prep ZP3; Stage 2 – Clean Rinse Stage; and Stage 3 – Fresh Water. Stage 1 is a heated stage using Houghto-Prep ZP3 that displaces surface soils and oils and using an efficient proprietary zirconium oxide chemistry, producing an amorphous coating that promotes paint adhesion and salt spray resistance. The inspectors observed an oil skimmer inside an open tote and a 55-gallon drum of used oil with released oil on top (Pictures 15-18). The used oil tote and drum were not closed or labeled.

Picture 15 – Stage 1 oil skimmer tote and used oil drum

Picture 16 – Stage 1 oil skimmer tote

Picture 17 – Stage 1 oil skimmer tote and used oil drum

Picture 18 – Stage 1 used oil drum with release on top

Pursuant to ADEM Admin. Code r. 335-14-17-.03(4)(c)1. [40 C.F.R. § 279.22(c)(1)], containers and aboveground tanks used to store used oil at generator facilities must be labeled or marked clearly with the words “Used Oil.”

Pursuant to ADEM Admin. Code r. 335-14-17-.03(4)(a)1., a container holding used oil must always be closed during storage, except when it is necessary to add or remove used oil. Stage 2 uses water and defoamer only, which are recycled in the process. Stage 3 is a fresh water rinse. On the opposite side of the process is a waste water holding tank. The waste water from the

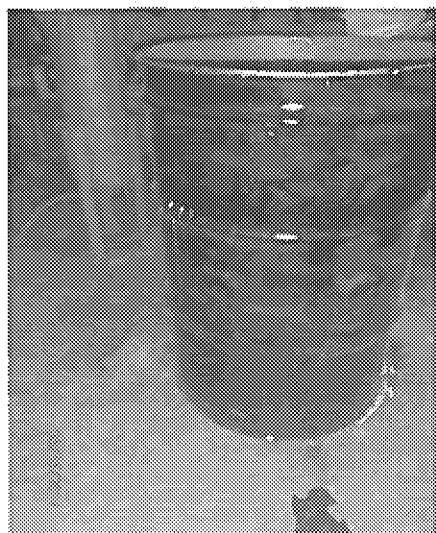
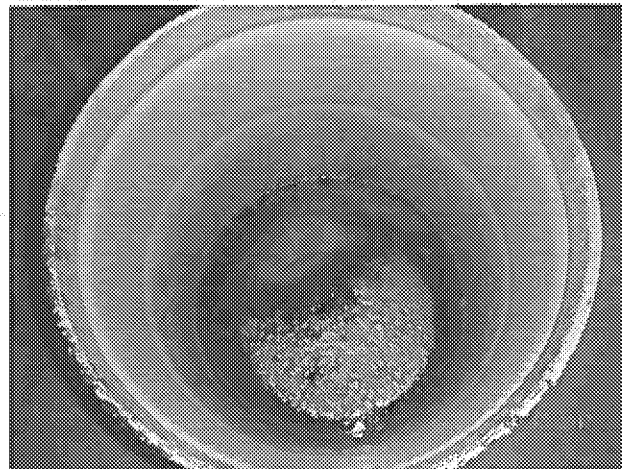
The inspectors also observed an open black 55-gallon drum of liquid waste near beginning of the process (Pictures 13-14).

Picture 14 – Flow Coat Process waste liquid drum not labeled

Picture 13 – Flow Coat Process waste liquid drum not labeled

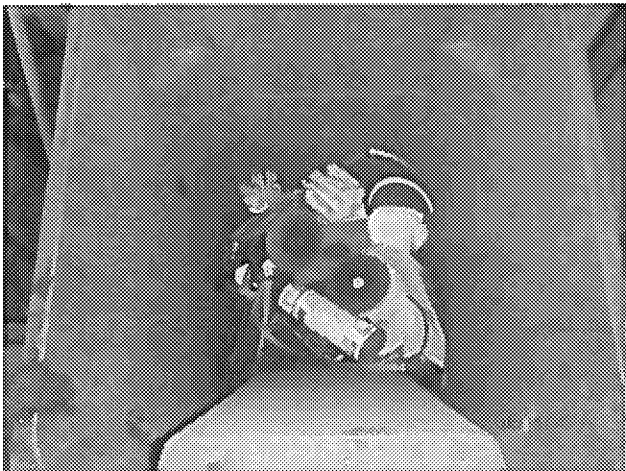
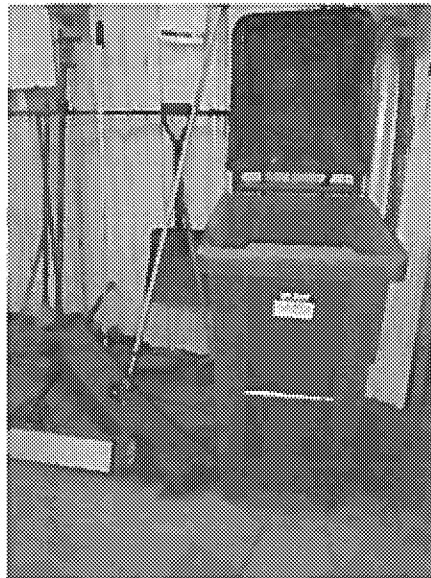
The weld shop was split into two areas. The first area was automated MIG welding using silicon bronze wire. Large pieces are loaded and cut with this welder. The second area used cup guns that are discarded when the welders are clogged up. The inspectors walked through the weld shops and observed discarded aerosol cans inside a blue trash container (Pictures 19-20). The discarded cans were not RCRA empty. Again, the inspectors stated that discarded aerosol cans that are not RCRA empty should be collected and stored until a waste determination can be conducted.

Picture 19 – Weld Shop blue trash can with discarded aerosol can inside

Picture 20 – Weld Shop blue trash can with discarded aerosol can inside

Pursuant to ADEM Admin. Code r. 335-14-3-.01(2) [40 C.F.R. § 262.11], a person who generates a solid waste, as defined in ADEM Admin. Code r. 335-14-2-.01(2) [40 C.F.R. § 261.2], must determine if that waste is a hazardous waste following the methods articulated in ADEM Admin. Code r. 335-14-3-.01(2) [40 C.F.R. § 262.11].

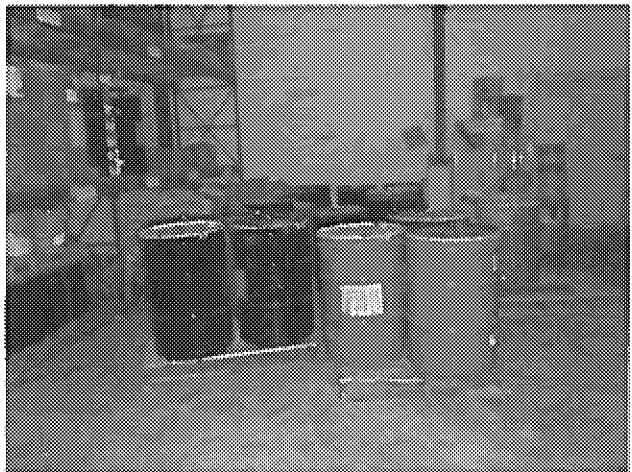
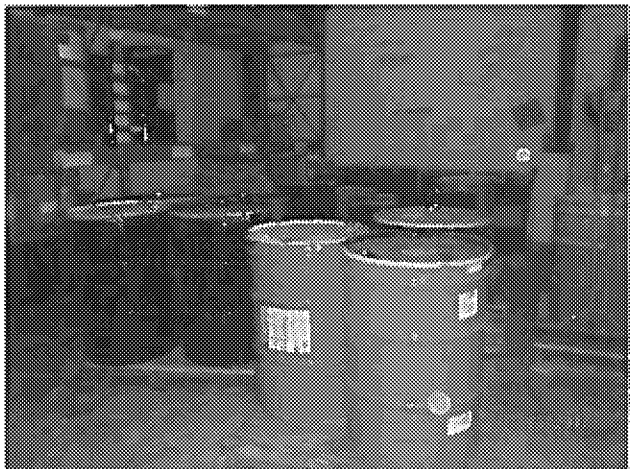
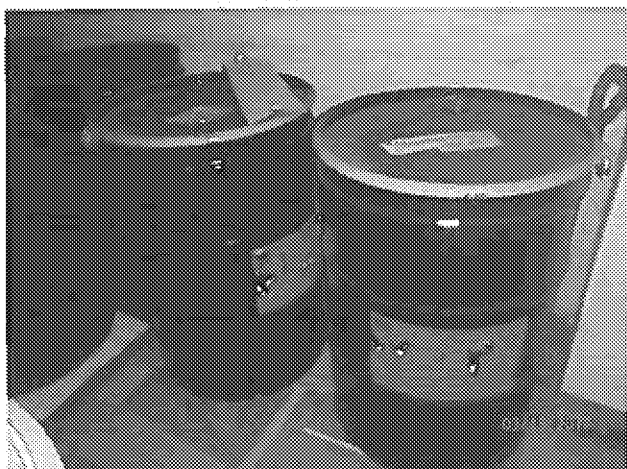
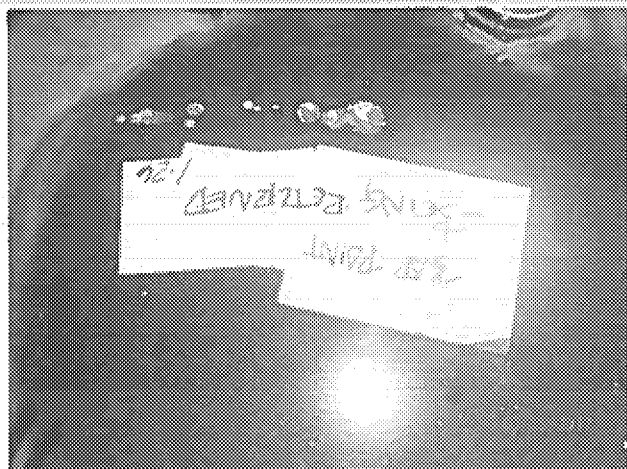
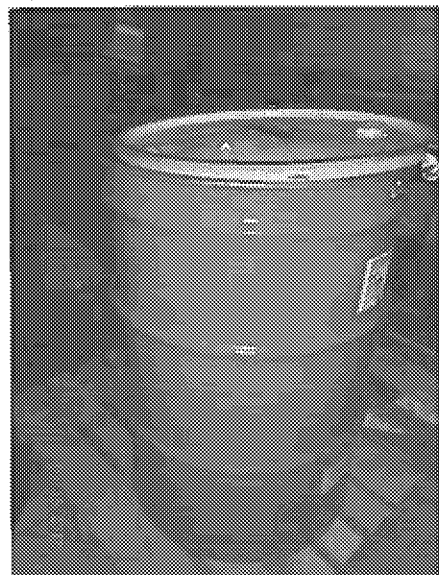
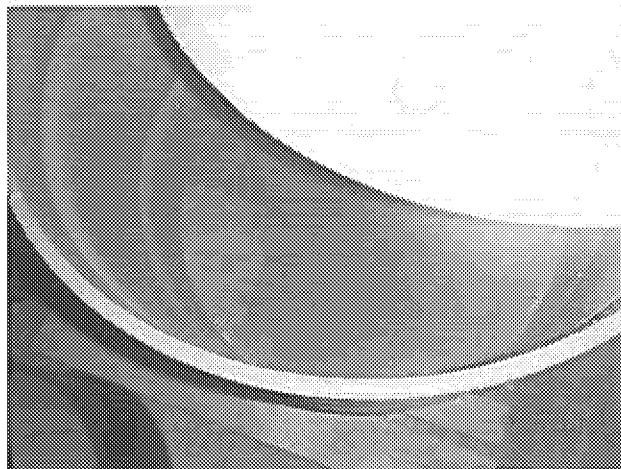
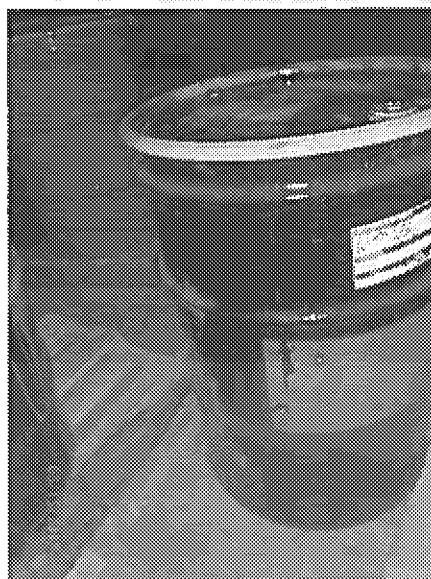
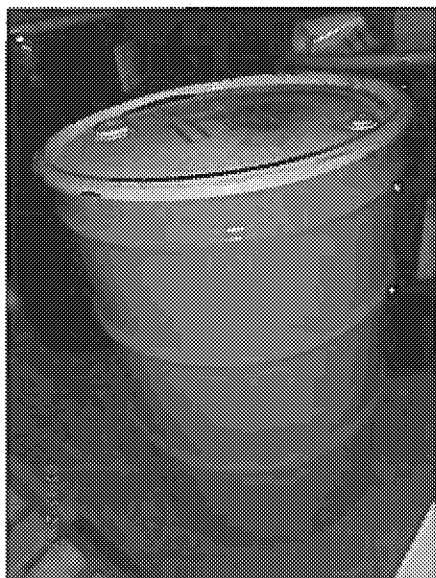
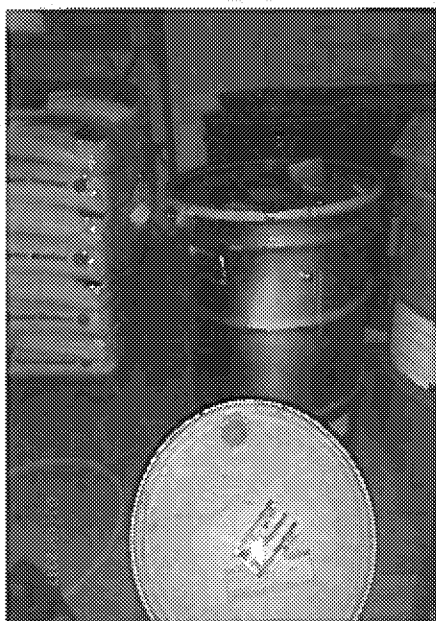
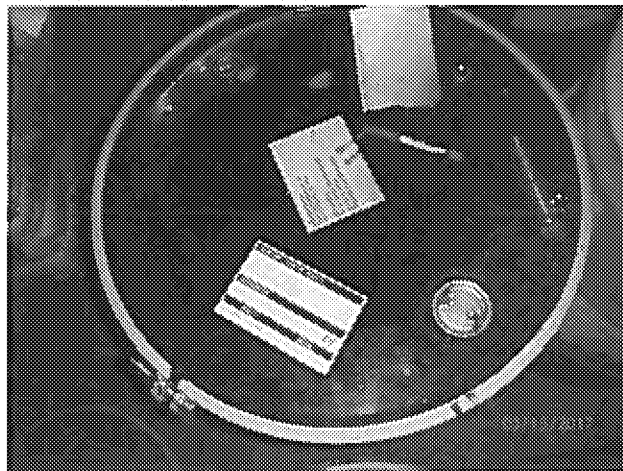
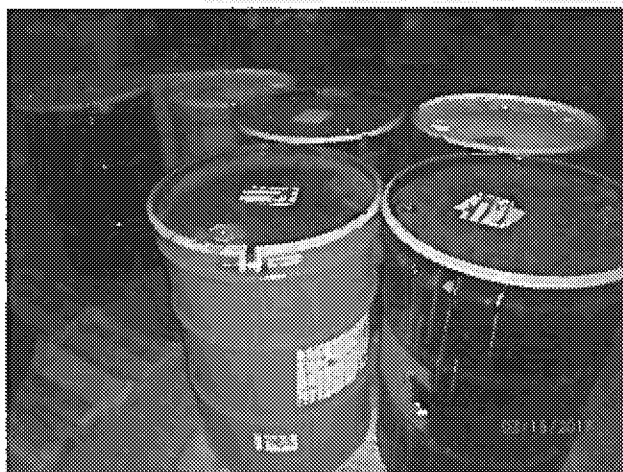
The chemical storage building is used for material supply and waste storage. At the time of the inspection, the inspectors observed the following (Pictures 21-32):

- Two 55-gallon drums of bad paint closed, labeled "being returned" and dated January 26, 2017;
- One blue 55-gallon drum not closed, labeled "Waist partial 3-6-17";
- One 55-gallon drum closed, labeled "Waste Oil" and dated July 20, 2016;
- One 55-gallon drum of mop waste, closed, labeled "Floor Waste (SB)" and not dated;
- One 55-gallon drum next to the floor waste drum that was closed, not labeled or dated;
- Four 55-gallon drums of liquid waste (LW) closed, labeled and dated March 1, 2017, March 6, 2017 (2 drums) and March 7, 2017;
- Two 55-gallon drums on the same pallet as the liquid waste drums closed but not labeled or dated; and
- One 55-gallon drum of waste water (liquid waste) closed, labeled and dated February 27, 2017.

Picture 21 – Chemical storage waste drums

Picture 22 – Chemical storage waste drums

Picture 23 – Chemical storage bad paint drums

Picture 26 – Chemical storage blue drum of “waist partial 3-6-17”

Picture 24 – Chemical storage bad paint drums

Picture 27 – Chemical storage waste oil drum

Picture 25 – Chemical storage blue drum of “waist partial 3-6-17”

Picture 28 – Chemical storage floor waste drum

Picture 29 – Chemical storage floor waste drum

Picture 30 – Chemical storage unknown and unlabeled drum

Picture 31 – Chemical storage unknown and unlabeled drum

Picture 32 – Chemical storage liquid waste drums

The inspectors explained that to ensure that the drums of floor waste, liquid waste and unknown waste are being properly disposed of waste determinations are required.

Pursuant to ADEM Admin. Code r. 335-14-3-.01(2) [40 C.F.R. § 262.11], a person who generates a solid waste, as defined in ADEM Admin. Code r. 335-14-2-.01(2) [40 C.F.R. § 261.2], must determine if that waste is a hazardous waste following the methods articulated in ADEM Admin. Code r. 335-14-3-.01(2) [40 C.F.R. § 262.11].

Pursuant to ADEM Admin. Code r. 335-14-17-.03(4)(c)1. [40 C.F.R. § 279.22(c)(1)], containers and aboveground tanks used to store used oil at generator facilities must be labeled or marked clearly with the words "Used Oil."

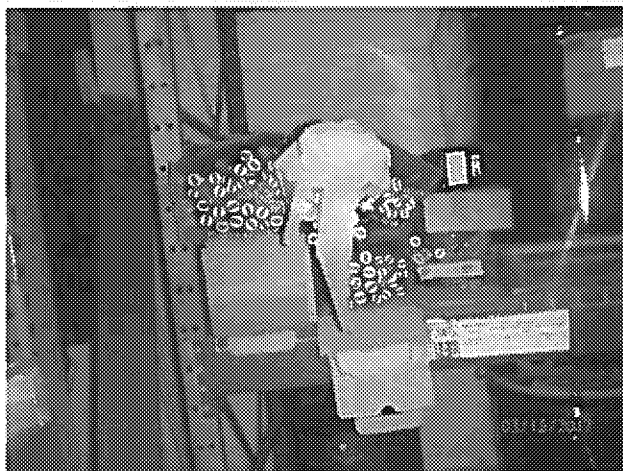
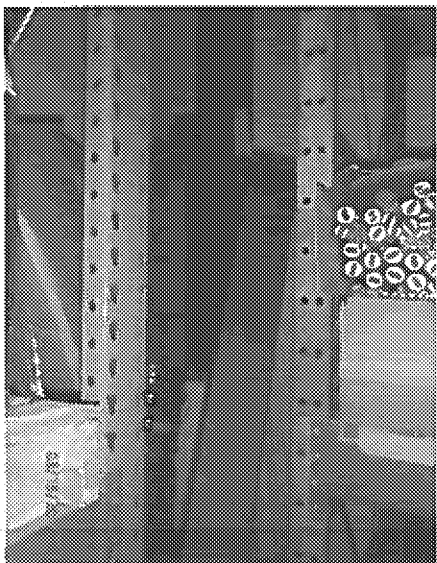
- Six 4-foot boxes of spent fluorescent lamps, five boxes were not closed, all of the boxes were not labeled or dated (Picture 33);
- One blue crate of spent light ballasts that was closed, not labeled or dated (Picture 38);
- One 55-gallon drum that was labeled "Fluorescent Bulb Waste", closed and not dated (Picture 38);
- Ten 4-foot spent fluorescent lamps wrapped in tissue that was not contained, labeled or dated (Picture 33);
- Four broken fluorescent lamps that were not contained, labeled or dated (Pictures 35-37);
- Three 8-foot spent fluorescent lamps were not contained, labeled or dated (Picture 34);
- Two 8-foot boxes of spent fluorescent lamps were not closed, labeled or dated (Picture 34);

Picture 33 – Chemical Storage universal waste lamps

Picture 34 -- Chemical Storage universal waste 8-foot lamps

The inspectors stated that universal waste lamps are required to be contained and the container kept closed, labeled "Universal Waste Lamps" and marked with the date the first lamp is placed into the container. At the time of the inspection, multiple lamps were not contained, boxes of spent lamps were not closed, none of the lamps were labeled or dated. The inspectors also explained that broken lamps could be a hazardous waste and should be properly managed.

Pursuant to ADEM Admin. Code r. 335-14-11-.02(5)(e) [40 C.F.R. § 273.14(e)], a SQHUW must label or mark each lamp or container of lamps clearly with one of the following phrases: "Universal Waste-Lamp(s)," or "Waste Lamp(s)," or "Used Lamps."

Pursuant to ADEM Admin. Code r. 335-14-11-.03(6)(a) and (c) [40 C.F.R. § 273.15(a) and (c)], a SQHUW may accumulate universal waste no longer than one year and must be able to demonstrate the length of time that the universal waste has accumulated from the date that it became a waste or was received.

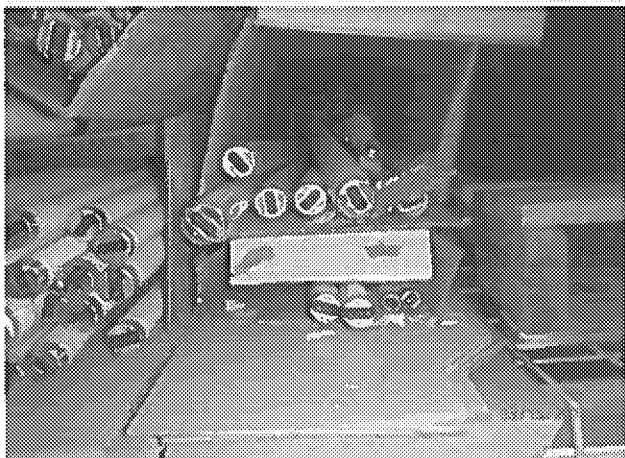
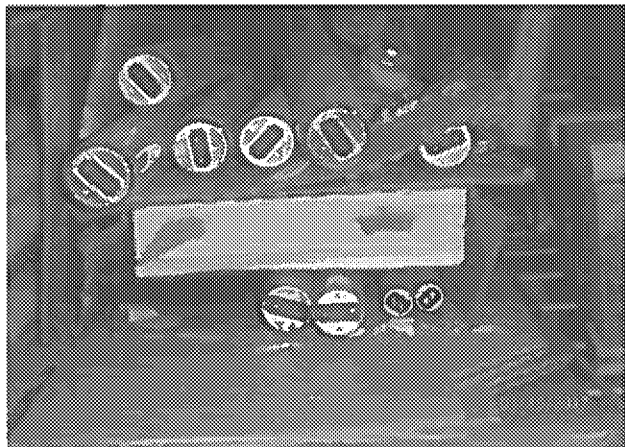
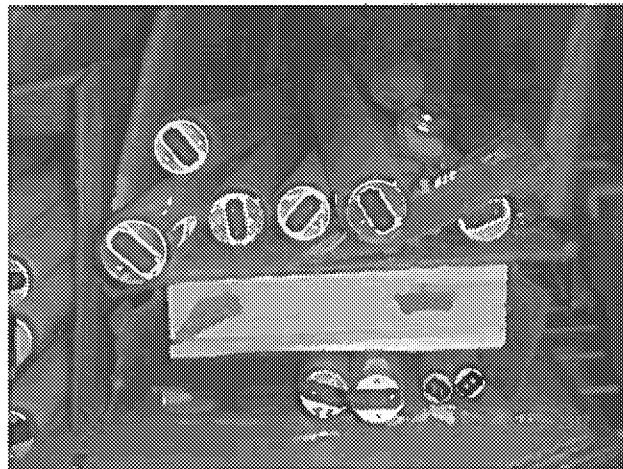
Pursuant to ADEM Admin. Code r. 335-14-3-.01(2) [40 C.F.R. § 262.11], a person who generates a solid waste, as defined in ADEM Admin. Code r. 335-14-2-.01(2) [40 C.F.R. § 261.2], must determine if that waste is a hazardous waste following the methods articulated in ADEM Admin. Code r. 335-14-3-.01(2) [40 C.F.R. § 262.11]. Four fluorescent lamps were observed broken and not contained.

Picture 37 -- Chemical Storage universal waste lamps broken

Picture 35 -- Chemical Storage universal waste lamps broken

Picture 36 -- Chemical Storage universal waste lamps broken

Pursuant to ADEM Admin. Code r. 335-14-11-.02(4)(d) [40 C.F.R. § 273.13(d)], a small quantity handler of universal waste (SQHUW) must manage universal waste lamps in a way that prevents releases of any universal waste or component of a universal waste to the environment.

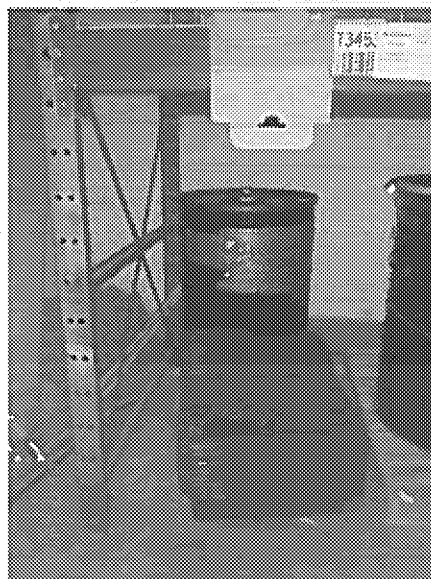
Picture 38 -- Chemical Storage universal waste lamp drum and spent ballast container

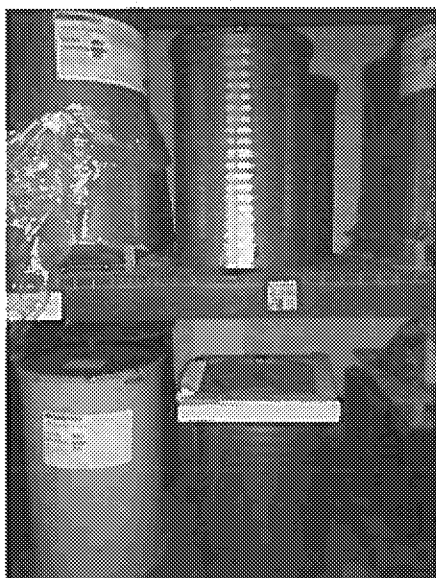
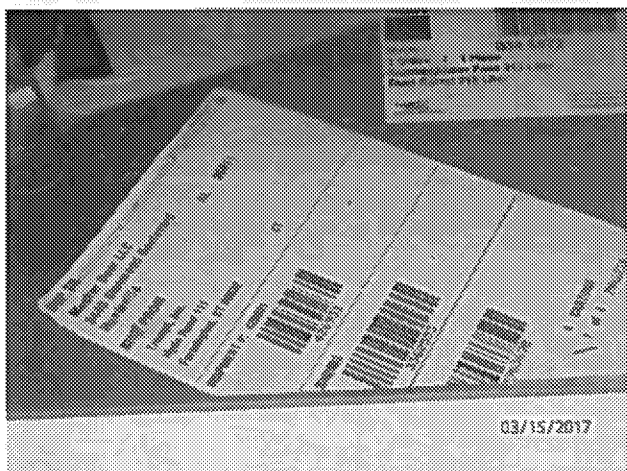
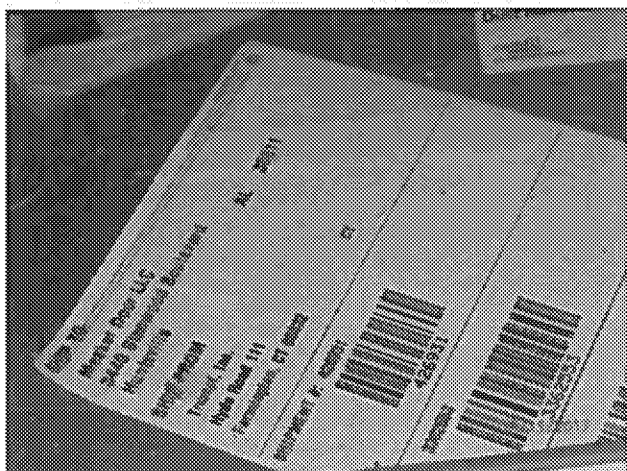
- Two full 55-gallon drums of non-hazardous laser cutter dust and one 55-gallon empty drum to be shipped back to the manufacturer Trumpf, Inc. in Farmington, CT (Pictures 39-41);
- Six spent paint aerosol cans thrown in the trash (Pictures 42-43);
- One paint roller dried with oil-based black paint to the paint tray (Pictures 46, 48);
- One pink container of lube discarded into a blue 55-gallon drum (Pictures 44-45);
- One pink container of lube discarded on top of an open one-gallon paint can filled with discarded butyl cellusolve (Pictures 46, 47, 49); and
- Two one-gallon cans of oil based paint (Pictures 51-52).

Picture 39 -- Chemical Storage laser cutter dust drums

Picture 40 -- Chemical Storage laser cutter dust drum label

Picture 41 -- Chemical Storage laser cutter dust drum label

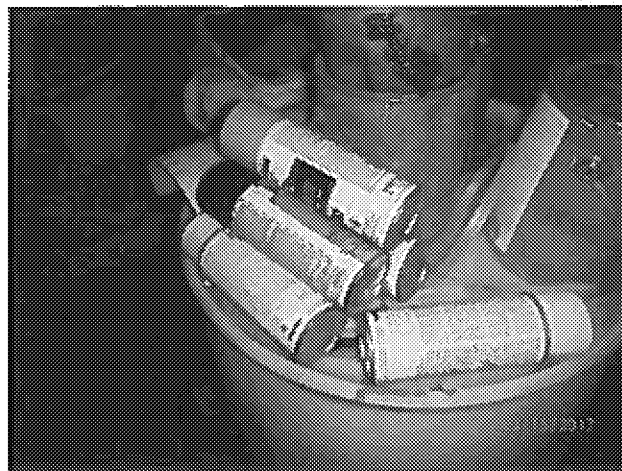
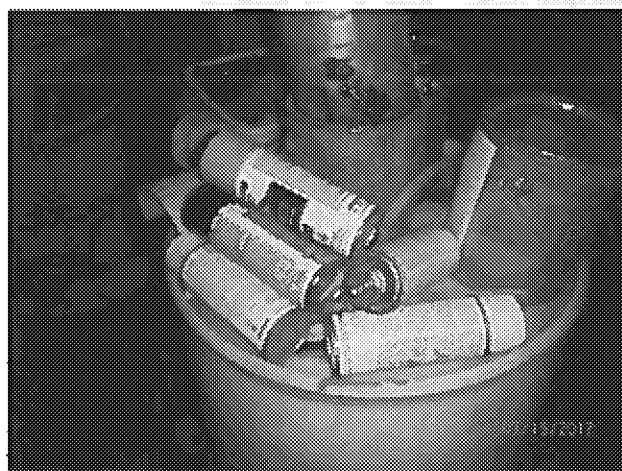
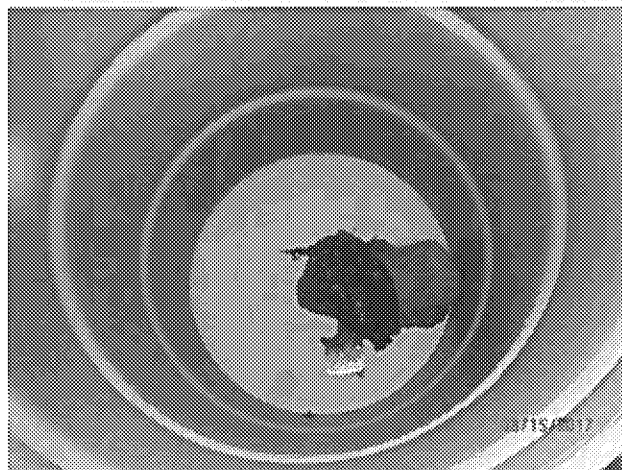
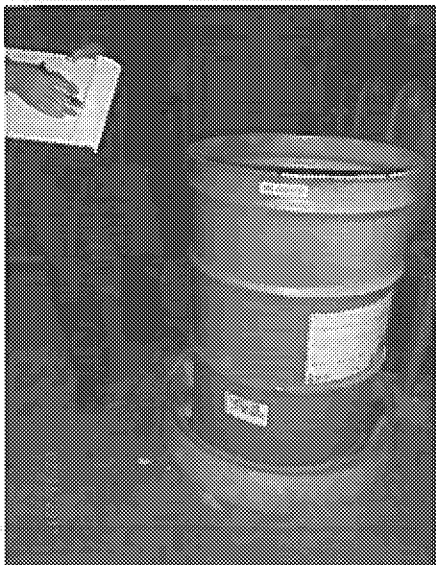
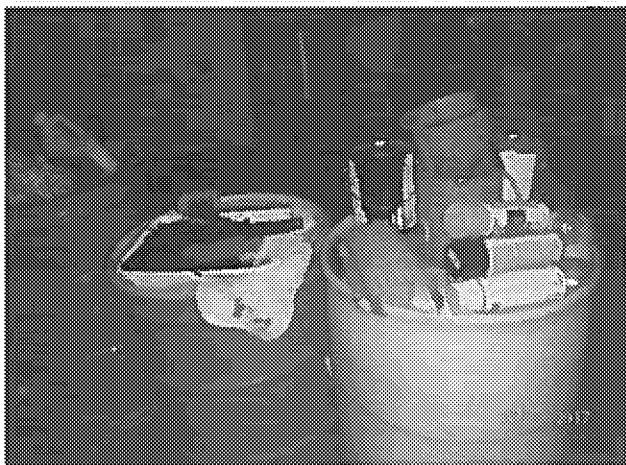
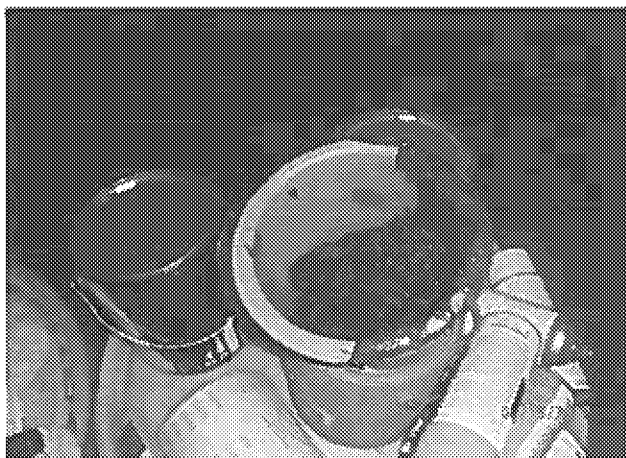
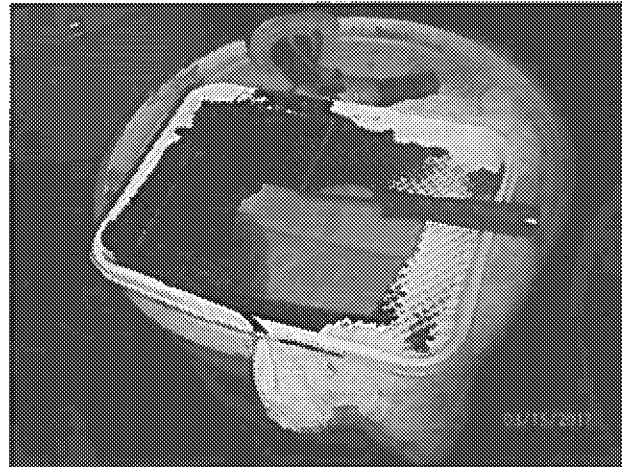
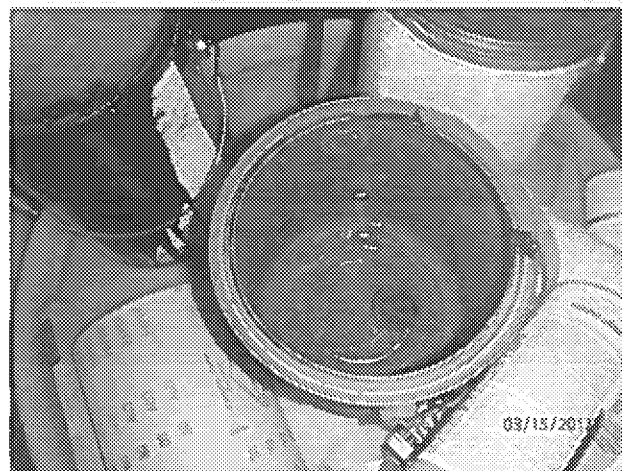
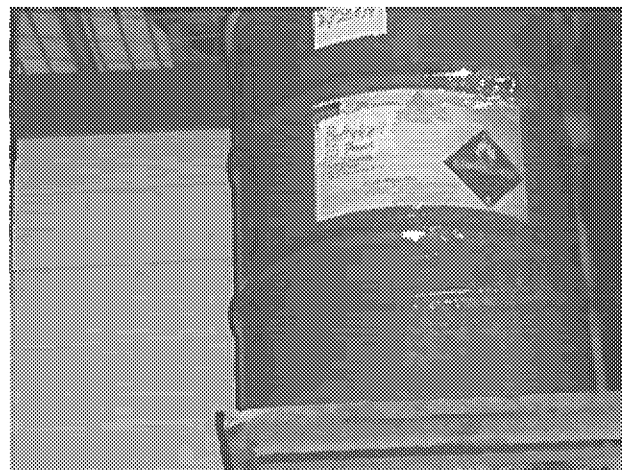
Picture 42 -- Chemical Storage spent aerosol can containers

Picture 43 -- Chemical Storage spent aerosol can containers

Picture 44 -- Chemical Storage discarded lube grease in a blue drum

Picture 45 -- Chemical Storage discarded lube grease in a blue drum

Picture 46 -- Chemical Storage discarded lube grease, aerosol cans, dried paint tray and roller

Picture 47 -- Chemical Storage discarded lube grease in a blue drum

Picture 48 -- Chemical Storage dried paint tray and roller with oil based paint

Picture 49 -- Chemical Storage discarded container of butyl cellulose

Picture 50 -- Chemical Storage drum of butyl cellulose

The inspectors explained that discarded aerosol cans that are not RCRA empty should be collected and stored until a waste determination can be conducted. Also inspectors observed based on the label and safety data sheet that the dried black oil-based paint in the tray had a flashpoint of 41 degrees C and contained solvents. The inspectors stated allowing the used paint to dry is considered illegal treatment, and a waste determination is required to determine if the used paint is hazardous.

Pursuant to ADEM Admin. Code r. 335-14-3-.01(2) [40 C.F.R. § 262.11], a person who generates a solid waste, as defined in ADEM Admin. Code r. 335-14-2-.01(2) [40 C.F.R. § 261.2], must determine if that waste is a hazardous waste following the methods articulated in ADEM Admin. Code r. 335-14-3-.01(2) [40 C.F.R. § 262.11].

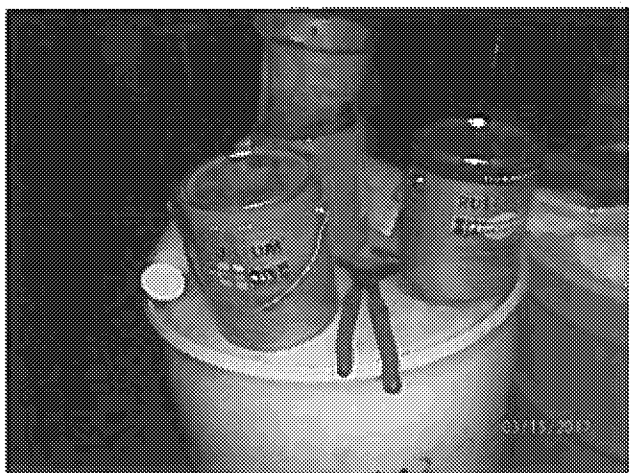
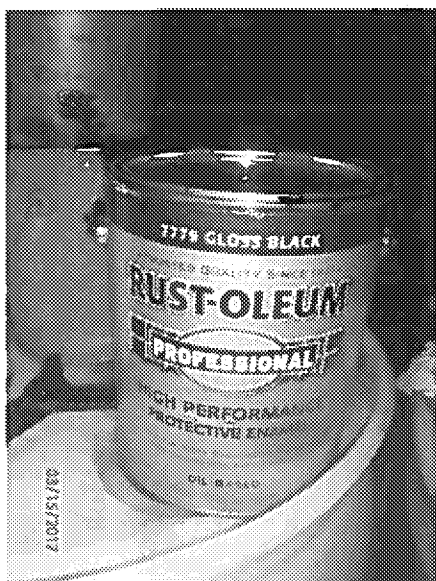
Picture 51 – Chemical Storage cans of oil based paint

Picture 52 – Chemical Storage can of oil based paint
